NATIONAL REGISTER OF HISTORIC PLACES  
MULTIPLE PROPERTY DOCUMENTATION FORM

DEPRESSION-ERA USDA FOREST SERVICE ADMINISTRATIVE COMPLEXES IN ARIZONA

EXAMPLE OF STANDARD PLANS

EXAMPLE OF ACCEPTABLE PLANS

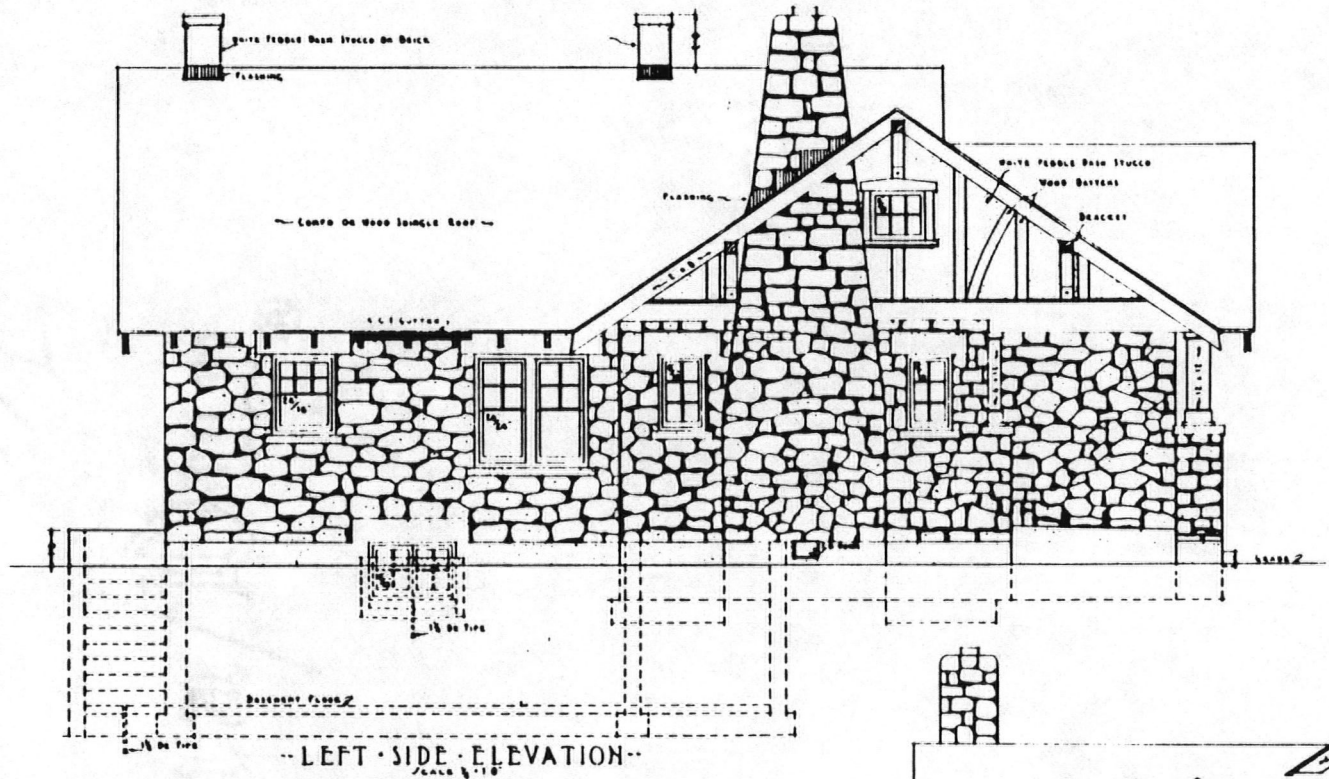
PLAN R-3-2A-3

-- LEFT SIDE ELEVATION --  
SCALE 1/4" = 1'-0"

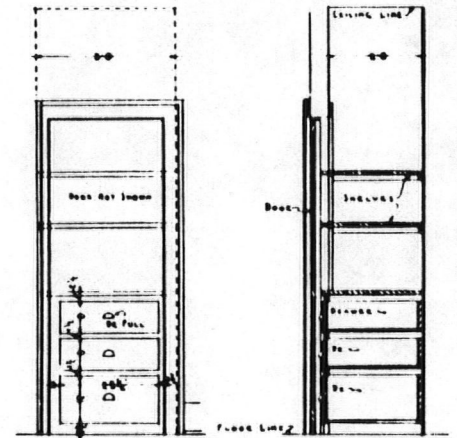
ELEVATION: --DETAIL OF LINEN CLOSET--  
SECTION:  
SCALE 1/4" = 1'-0"

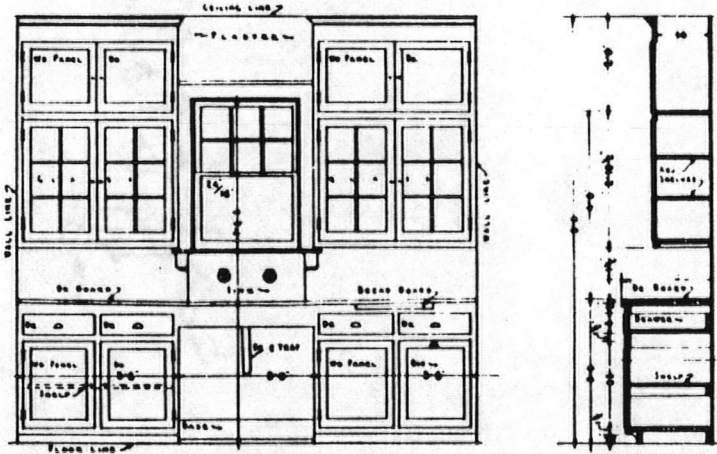
ELEVATION: --DETAIL OF KITCHEN CABINETS--  
SECTION:  
SCALE 1/4" = 1'-0"

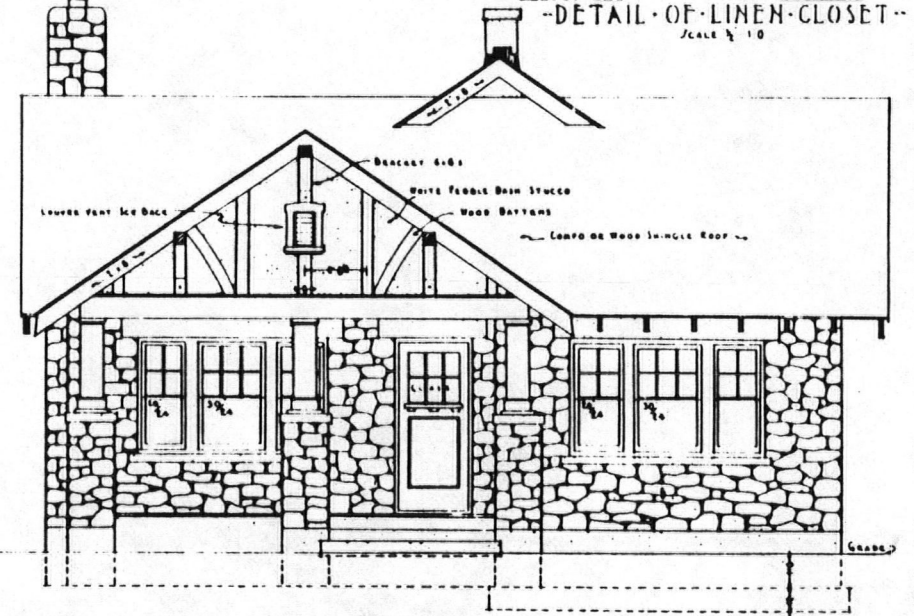
-- FRONT ELEVATION --  
SCALE 1/4" = 1'-0"

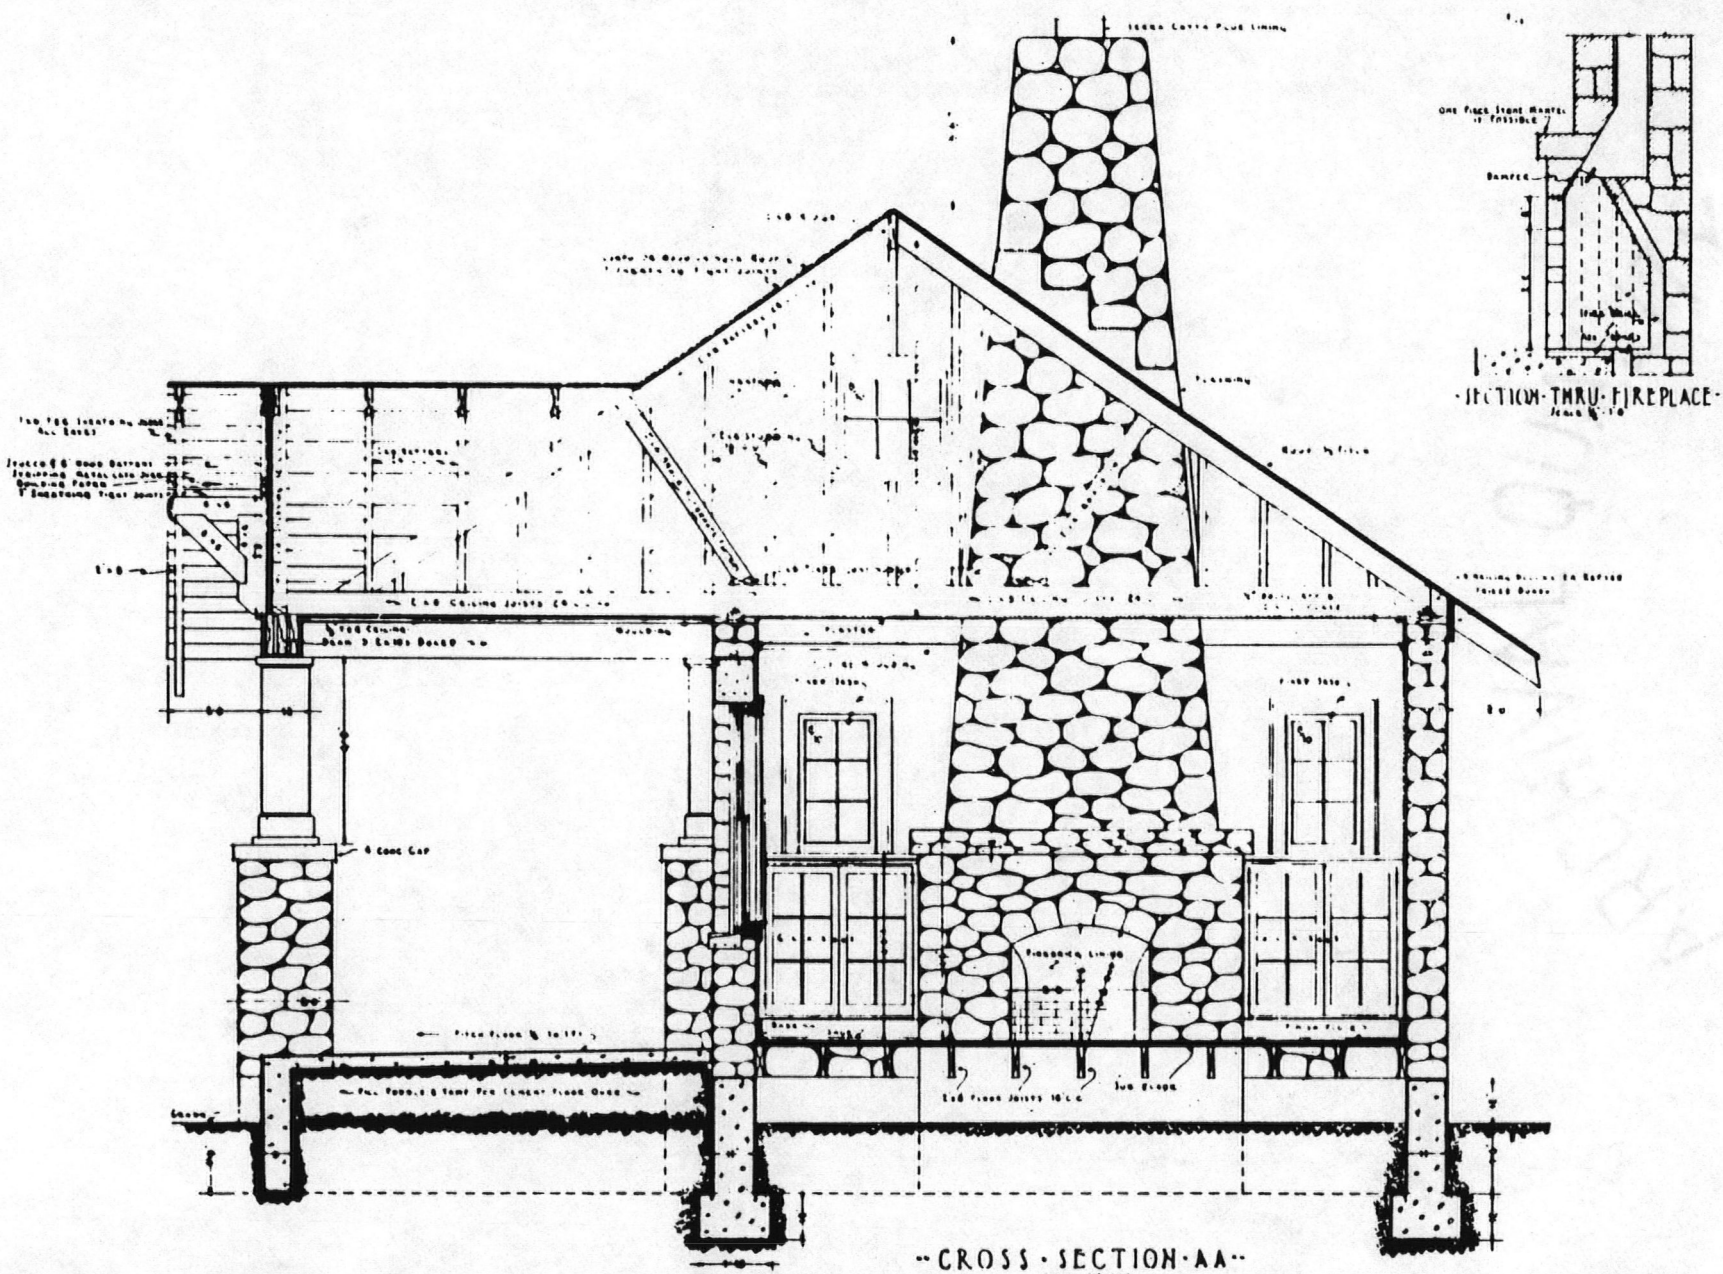
PLAN R-3-2A-3

-- CROSS SECTION AA --  
SCALE 1/8" = 1'-0"

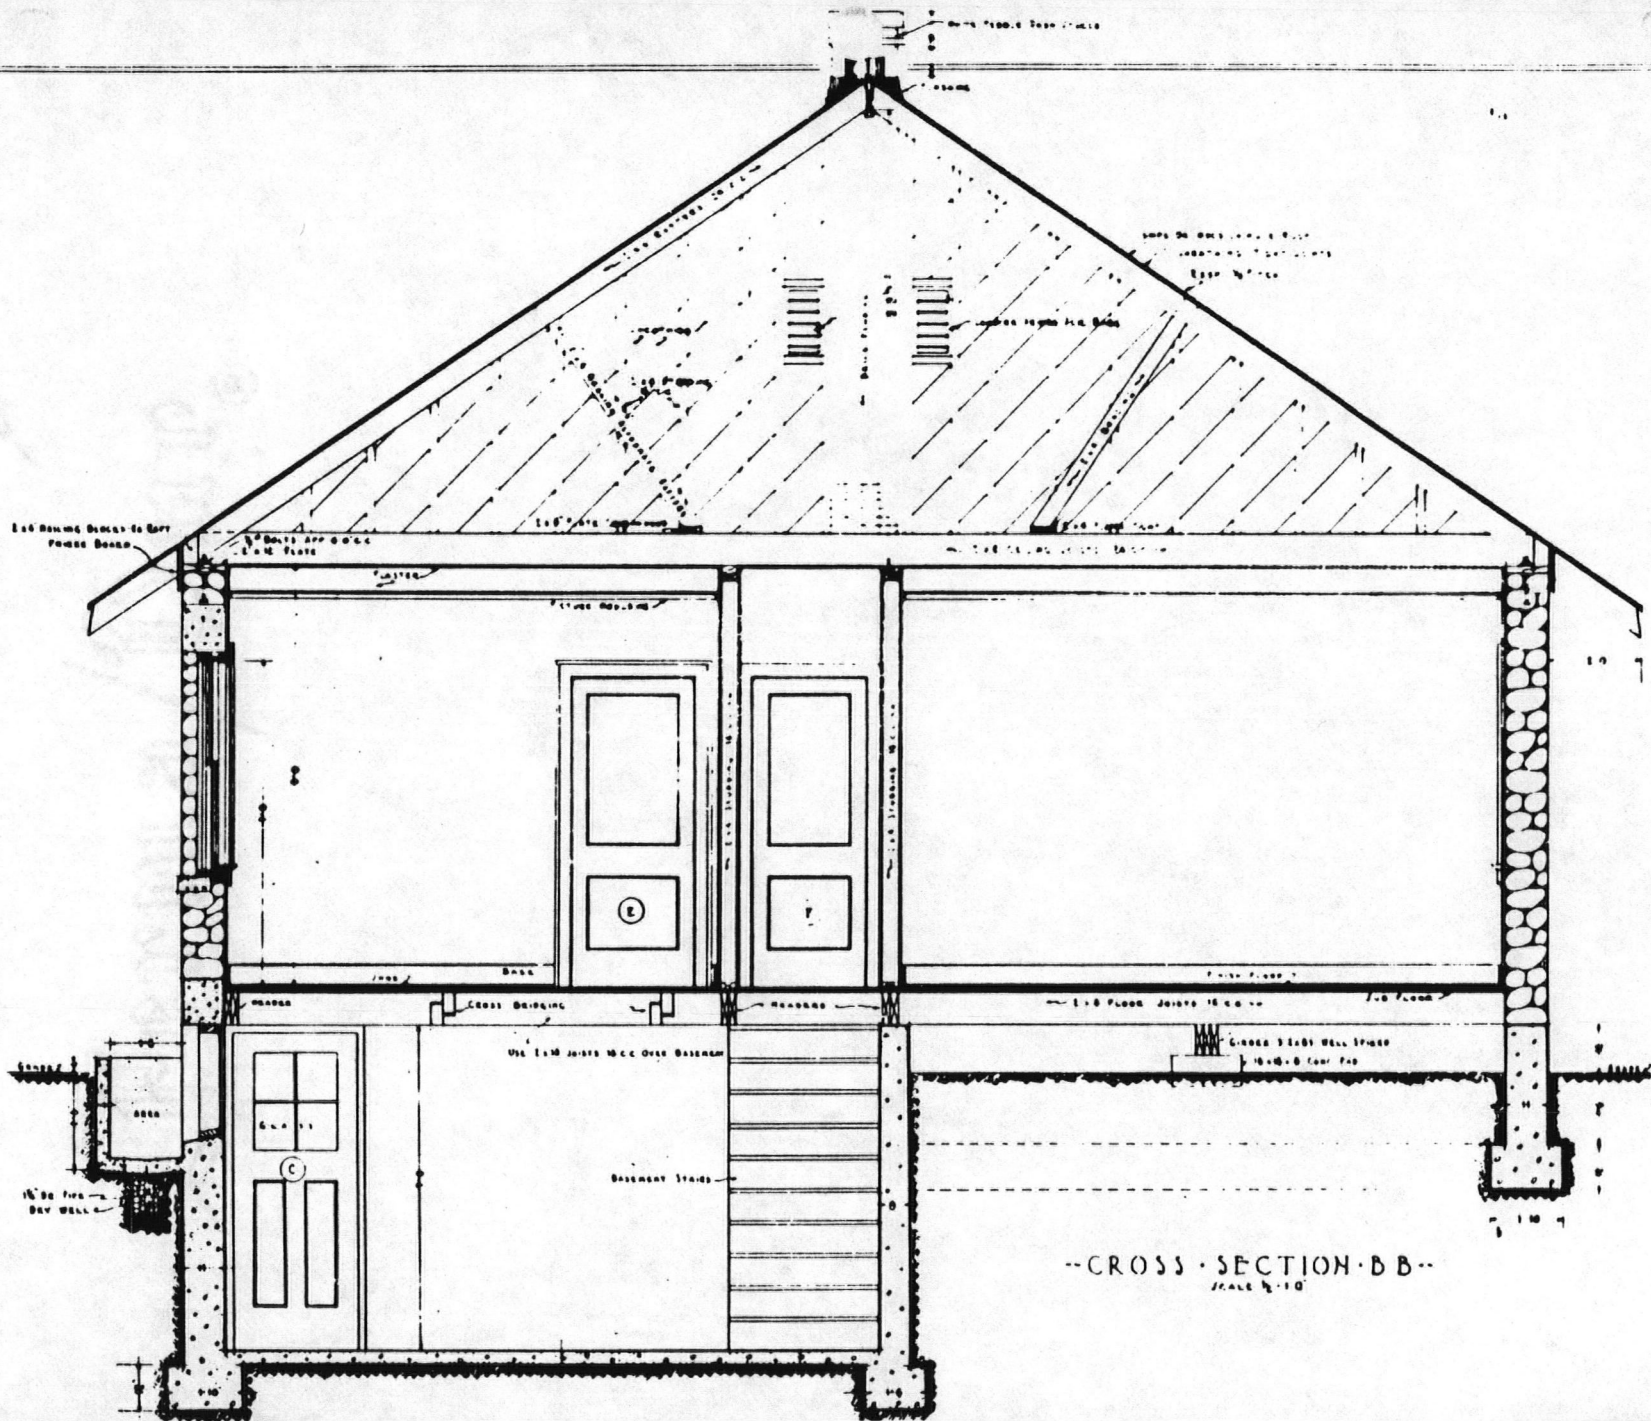
PLAN R-3-2A-3

--CROSS SECTION D.B.--  
SCALE 1/4" = 1'-0"

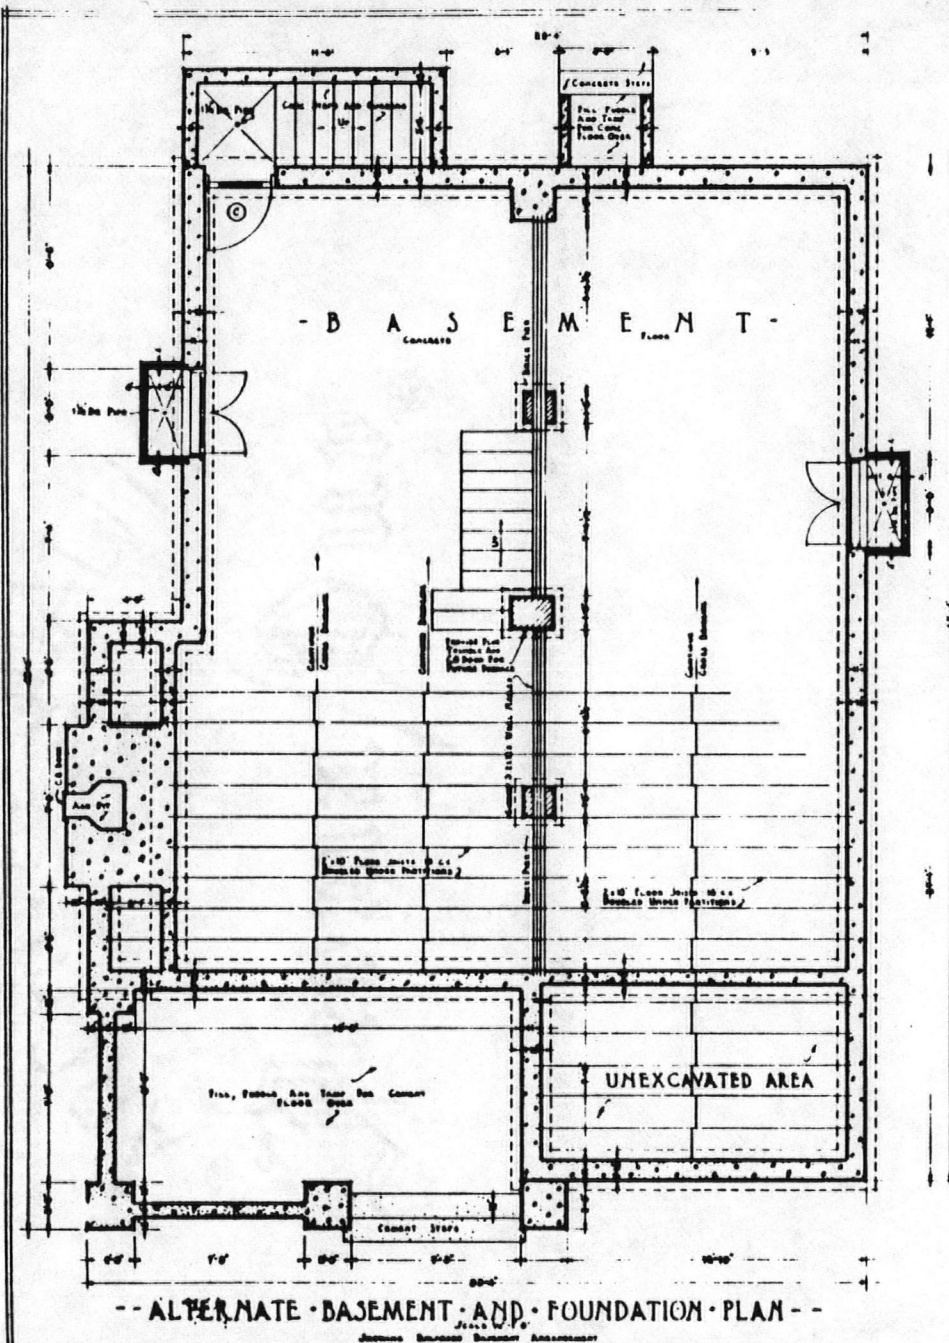
-- ALTERNATE BASEMENT AND FOUNDATION PLAN --

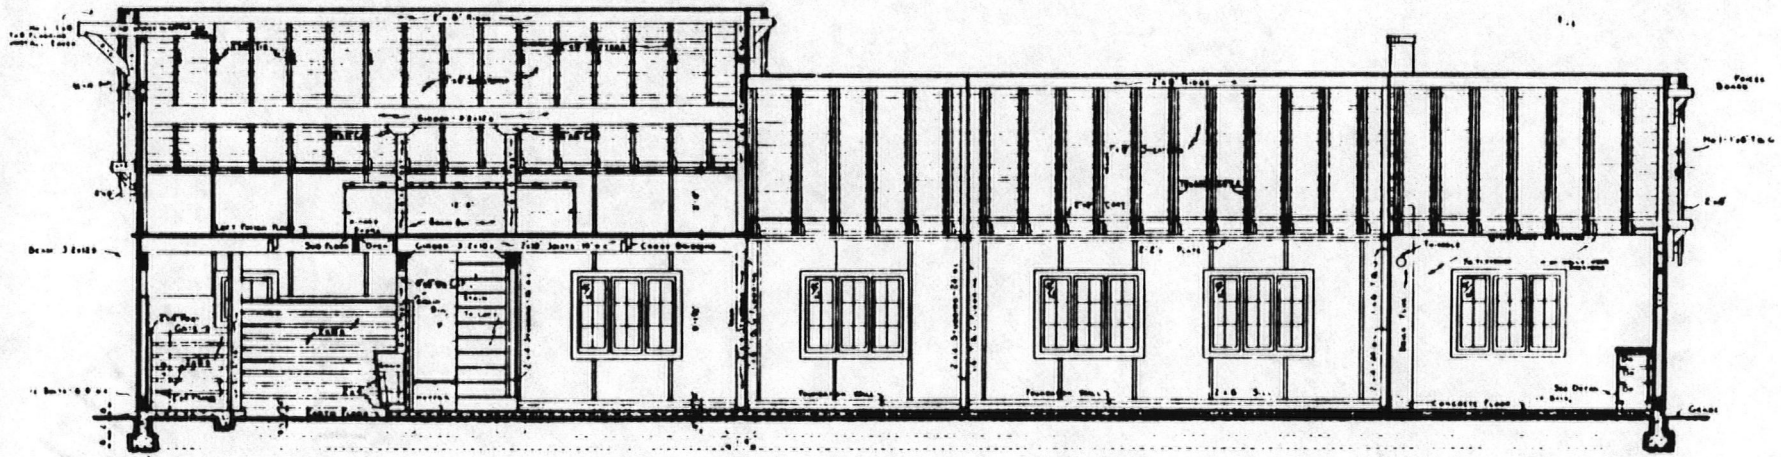
-- LONGITUDINAL SECTION --  
Scale 1/4" = 1'-0"

NOTE: LIST OF MEMBERS OF TRUSSED RAFTER ROOF CONSTRUCTION SHOWN ABOVE. THIS SECTION INDICATES ON THESE DRAWINGS THE CONCRETE FLOOR AND THE EXTERIOR WALLS. THE ESTIMATED LOADS SHOWN ARE THE LIVE LOAD OF 75 POUNDS PER SQUARE FOOT FOR ROOF AND WIND LOADS IN LOCALITY OF SMALL, OPEN AND RAMP LONGS. ESTIMATED LOADS SHOWN ARE THE LIVE LOAD OF 20 POUNDS PER SQUARE FOOT (SEE NOTE LIST OF MEMBERS AS INDICATED ON SECTION DRAWING)

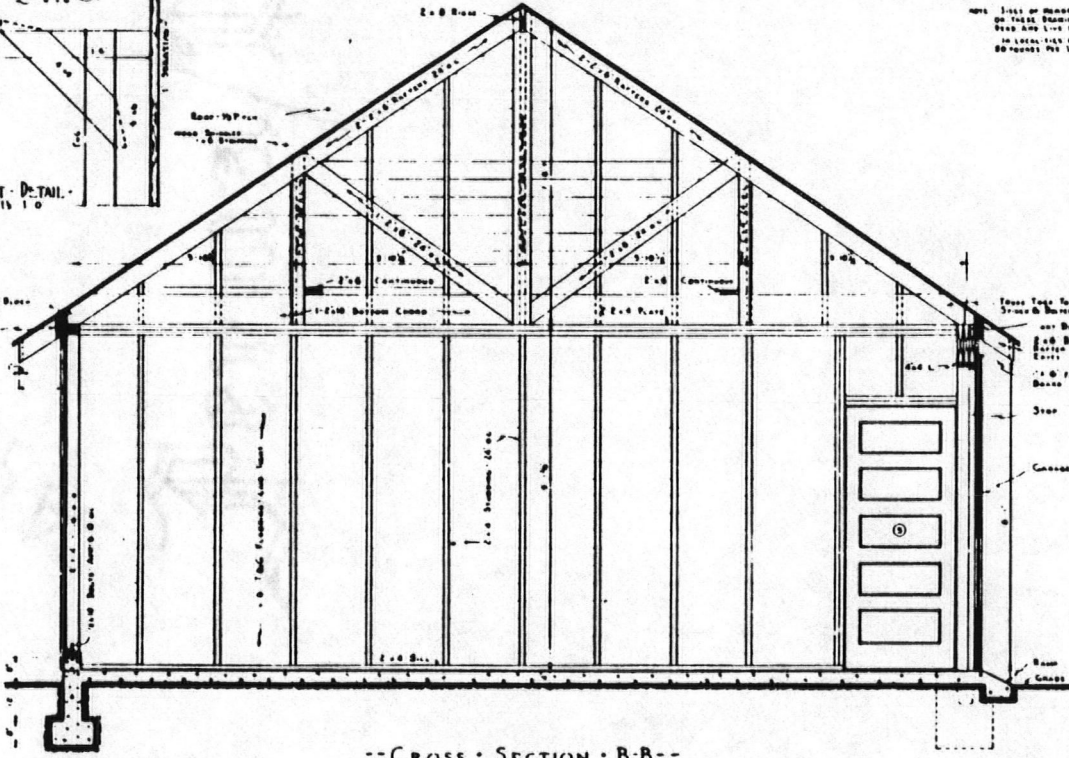
-- CROSS SECTION B-B --  
Scale 1/4" = 1'-0"

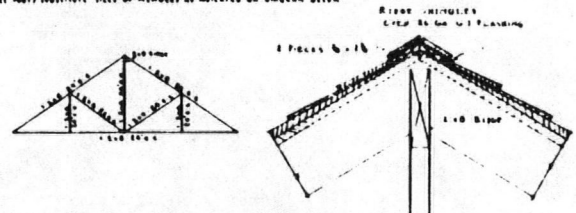
DETAIL SHOWING FLASHING UNDER RIDGE SHINGLES  
SCALE 1/2" = 1'-0"

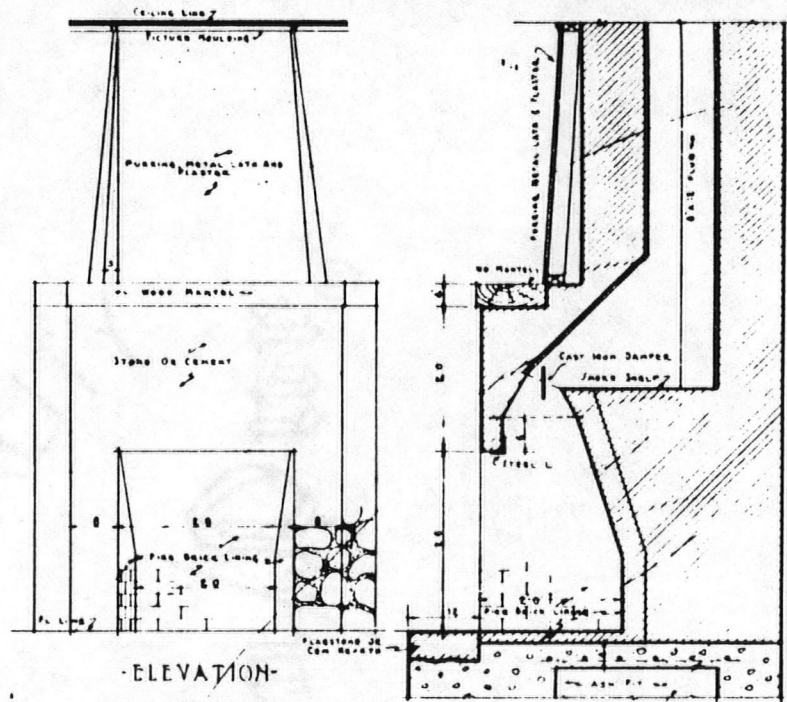
- ELEVATION -

- VERTICAL SECTION AT CENTER -

- FIREPLACE DETAILS -  
SCALE 1/4" = 1'-0"

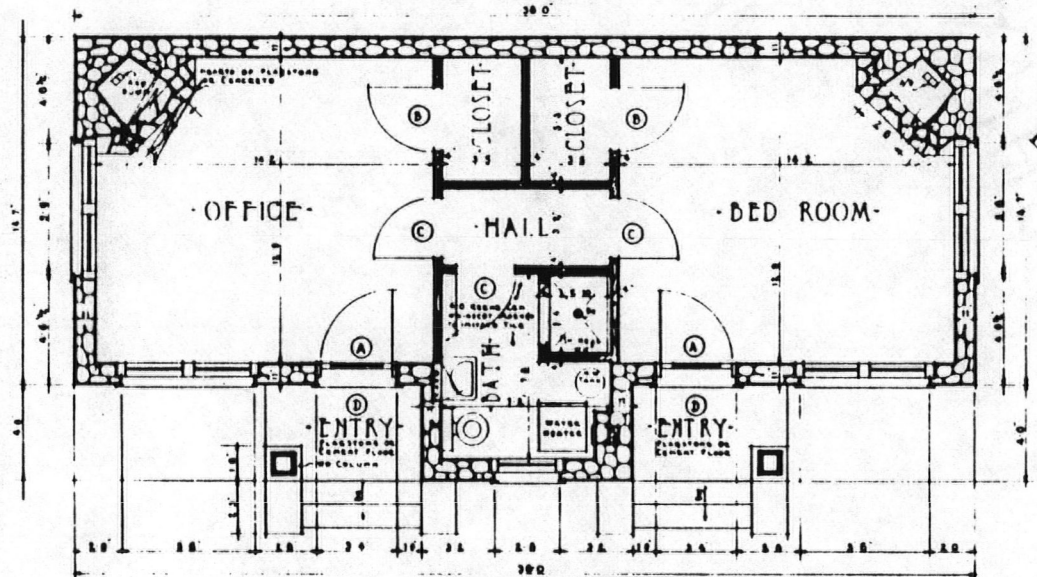
- FLOOR PLAN -  
SCALE 1/4" = 1'-0"

NOTE: DIMENSIONS INDICATE FRAMING SIZES AND DO NOT INCLUDE LATH & PLASTER.

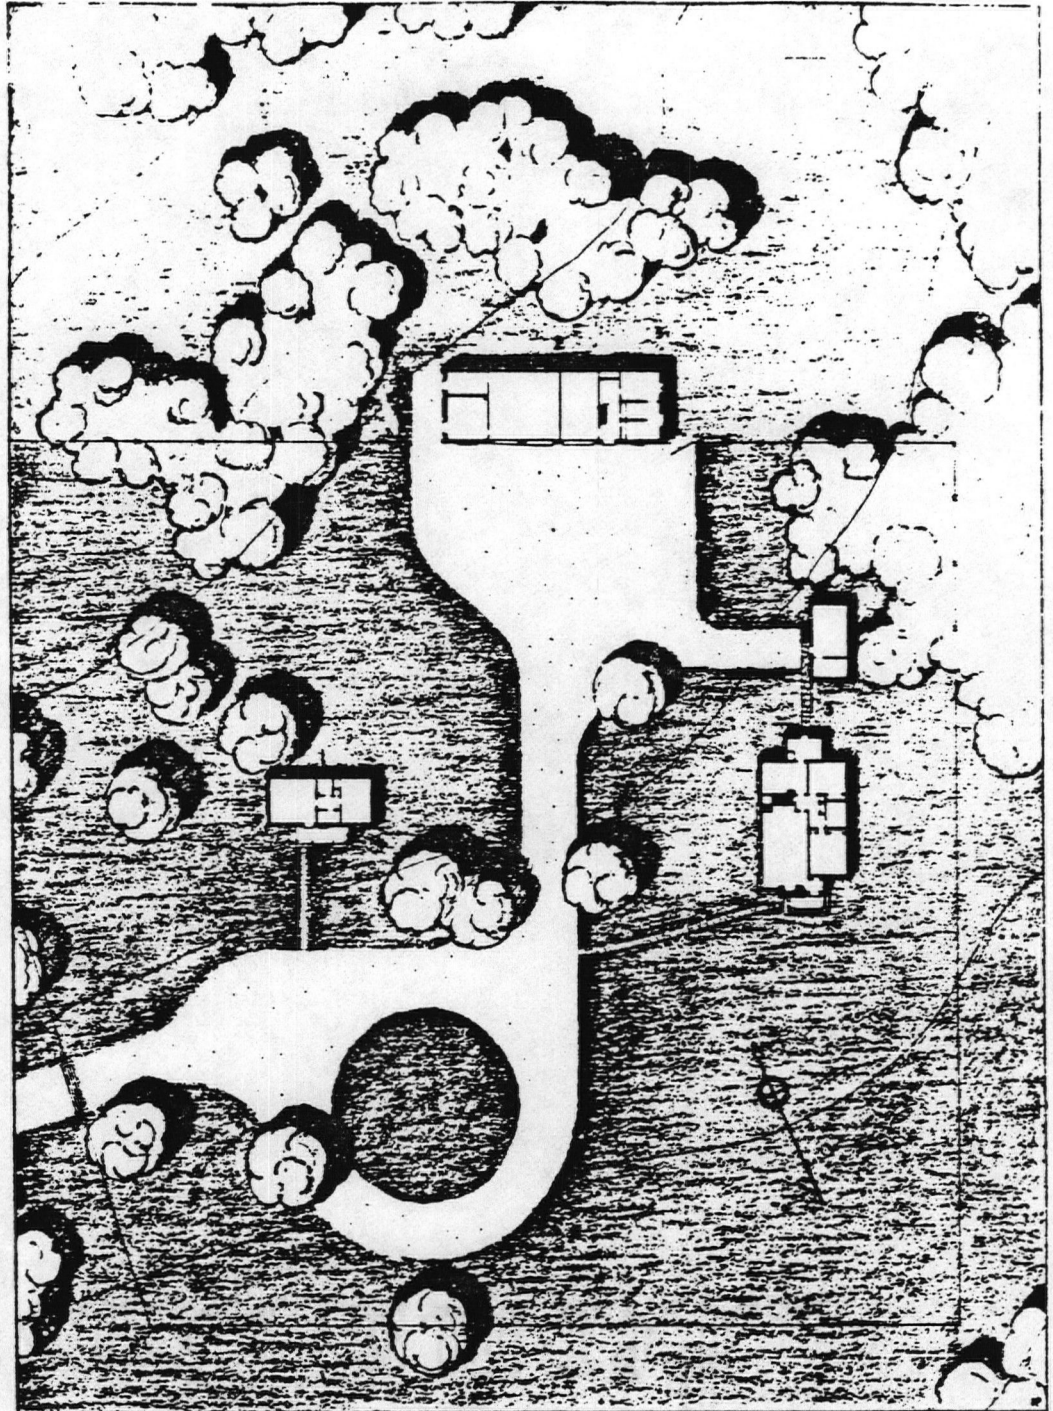
PLOT PLAN  
ANITA MOQUI RANGER STATION  
KAIBAB NATIONAL FOREST  
REGION 3

Figure 1  
Site layout for Moqui R.S. (from Acceptable Plans). Later revised.

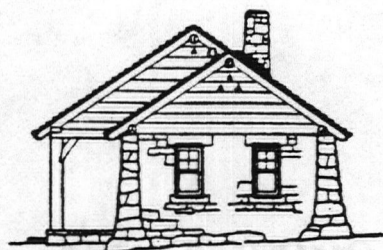
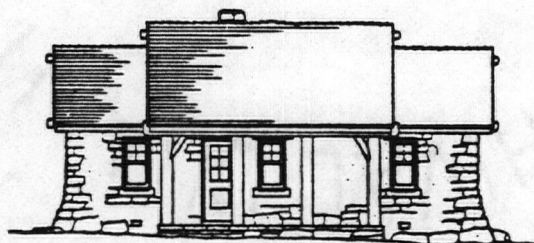
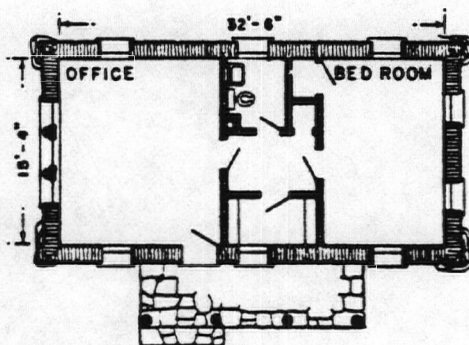
Figure 2

OFFICE  
ANITA MOQUI RANGER STATION  
KAIBAB NATIONAL FOREST  
REGION 3

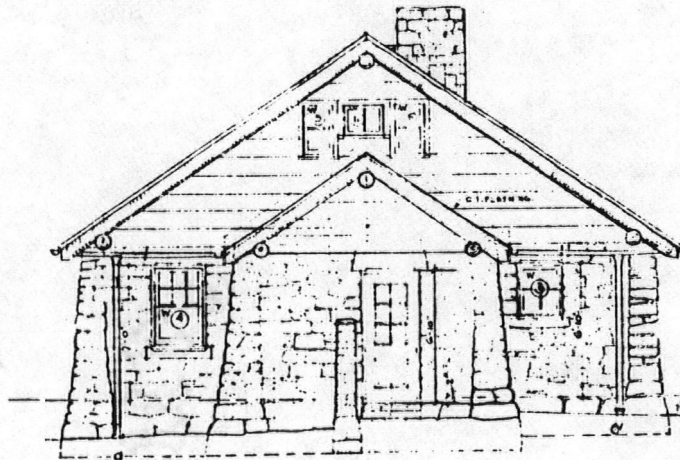
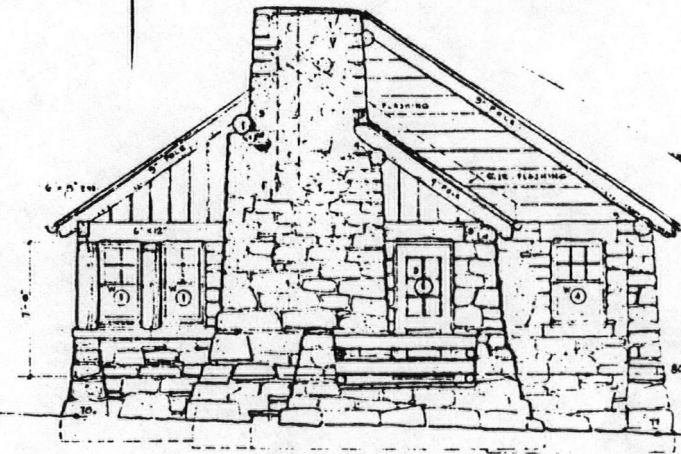
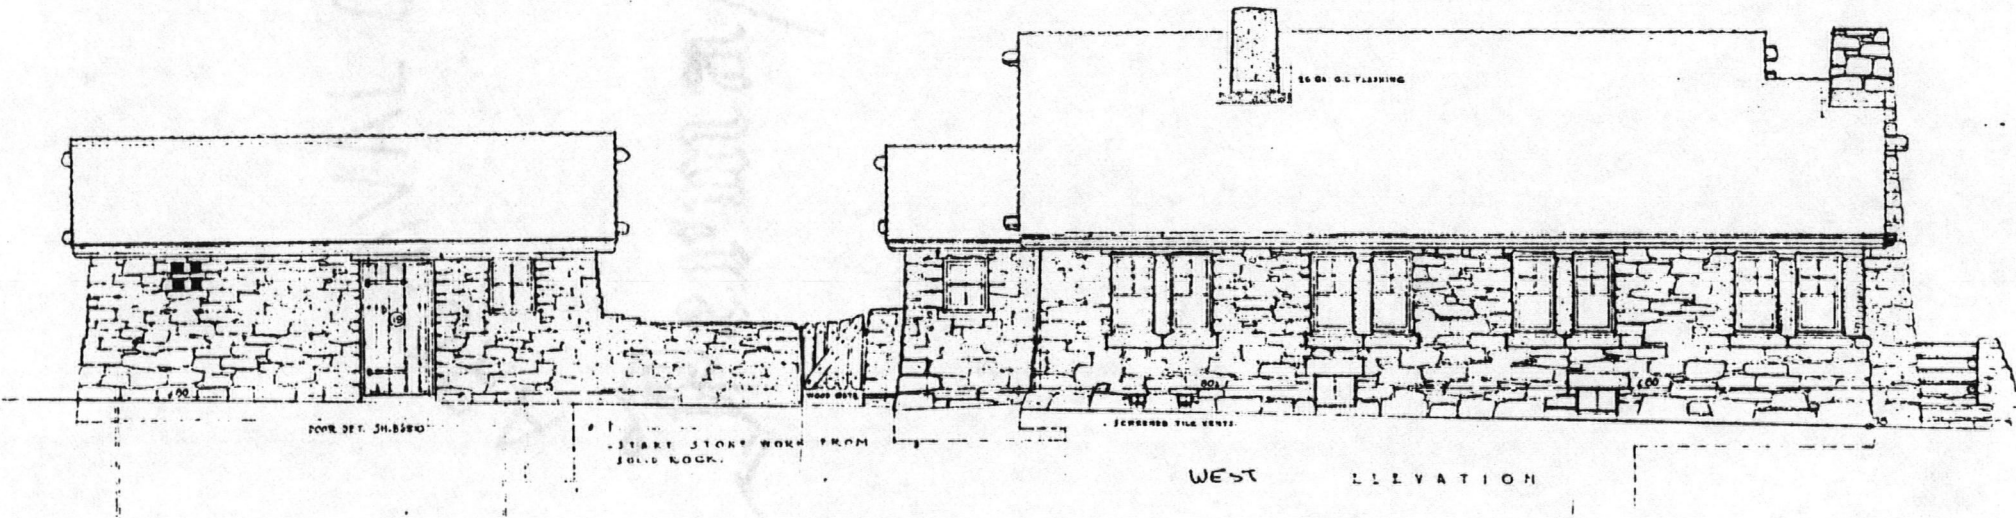
Figure 5

Elevation drawings for the Moqui R.S. Dwelling/Cistern, March, 1939.

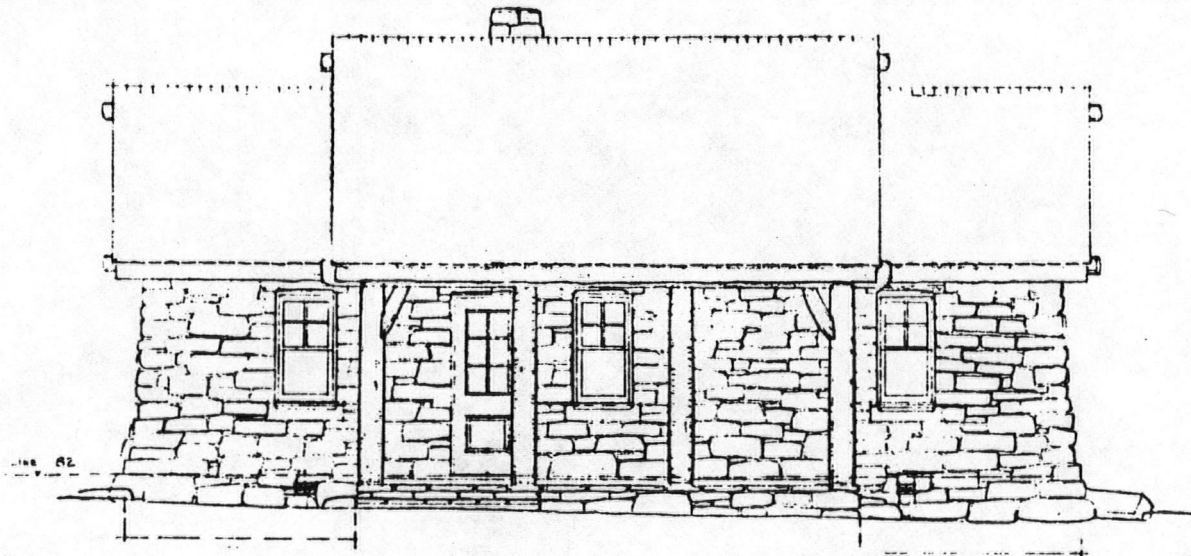
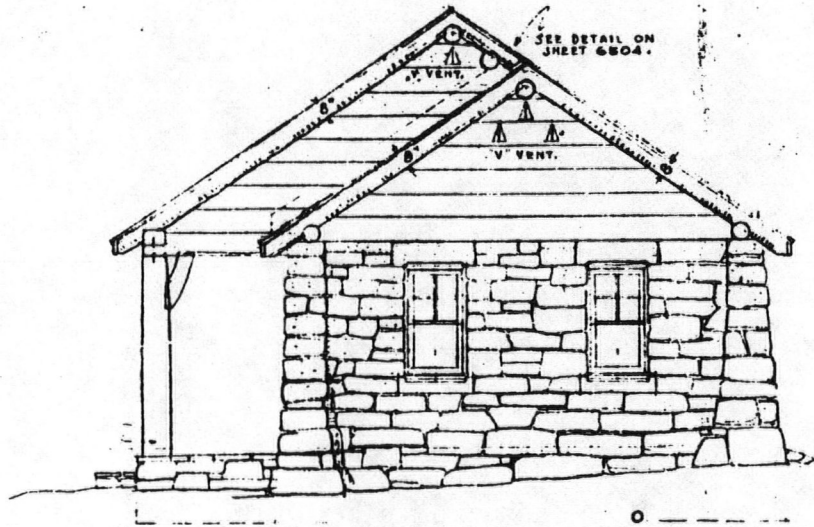
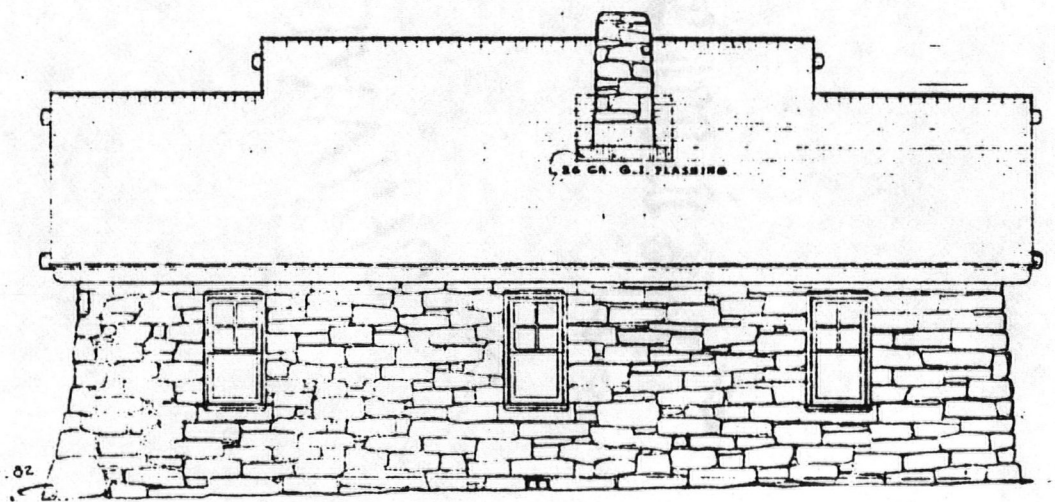
Figure 6

U.S. DEPARTMENT OF AGRICULTURE  
 FOREST SERVICE  
 REGION 3 REGIONAL ENGINEER  
 ANITA MOQUI R. S.  
 KAIBAB N. F.  
 OFFICE  
 DESIGNED G. G. W. DRAWN G. G. W. TRACED  
 SCALE 1/4 IN. = 1 FT. CHECKED  
 APPROVED A. R. F. DATE MARCH 1939  
 A. R. F. D6505
